# Home Report

# Single Survey

| Property address | 1 Baldowrie Farm Cottage<br>Kettins<br>Blairgowrie<br>PH13 9JT |
| Prepared by | Shepherd Chartered Surveyors |

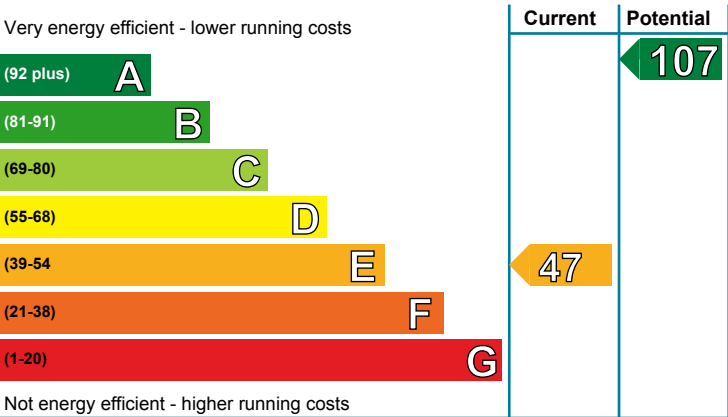
**Energy Efficiency Rating**

This graph shows the current efficiency of your home, taking into account both energy efficiency and fuel costs. The higher this rating, the lower your fuel bills are likely to be.

Your current rating is **band E (47)**. The average rating for EPCs in Scotland is **band D (61)**.

The potential rating shows the effect of undertaking all of the improvement measures listed within your recommendations report.

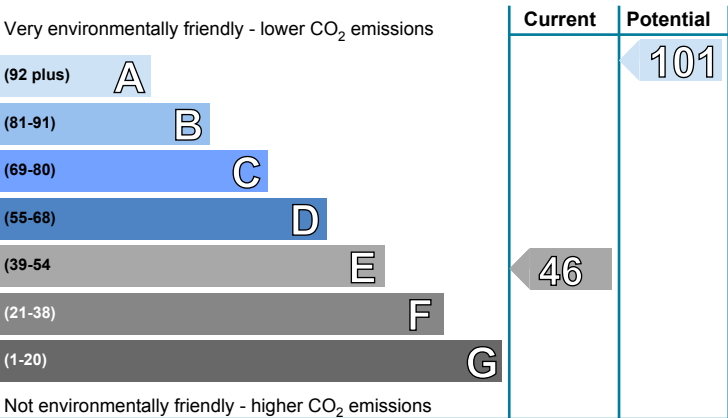
**Environmental Impact (CO<sub>2</sub>) Rating**

This graph shows the effect of your home on the environment in terms of carbon dioxide (CO<sub>2</sub>) emissions. The higher the rating, the less impact it has on the environment.
