YOUR ONESURVEY  
**HOME REPORT**

1 Trades Lane  
Coupar Angus, Blairgowrie  
PH13 9DN

# SINGLE SURVEY

A report on the condition of the property, with categories  
being rated from 1 to 3.

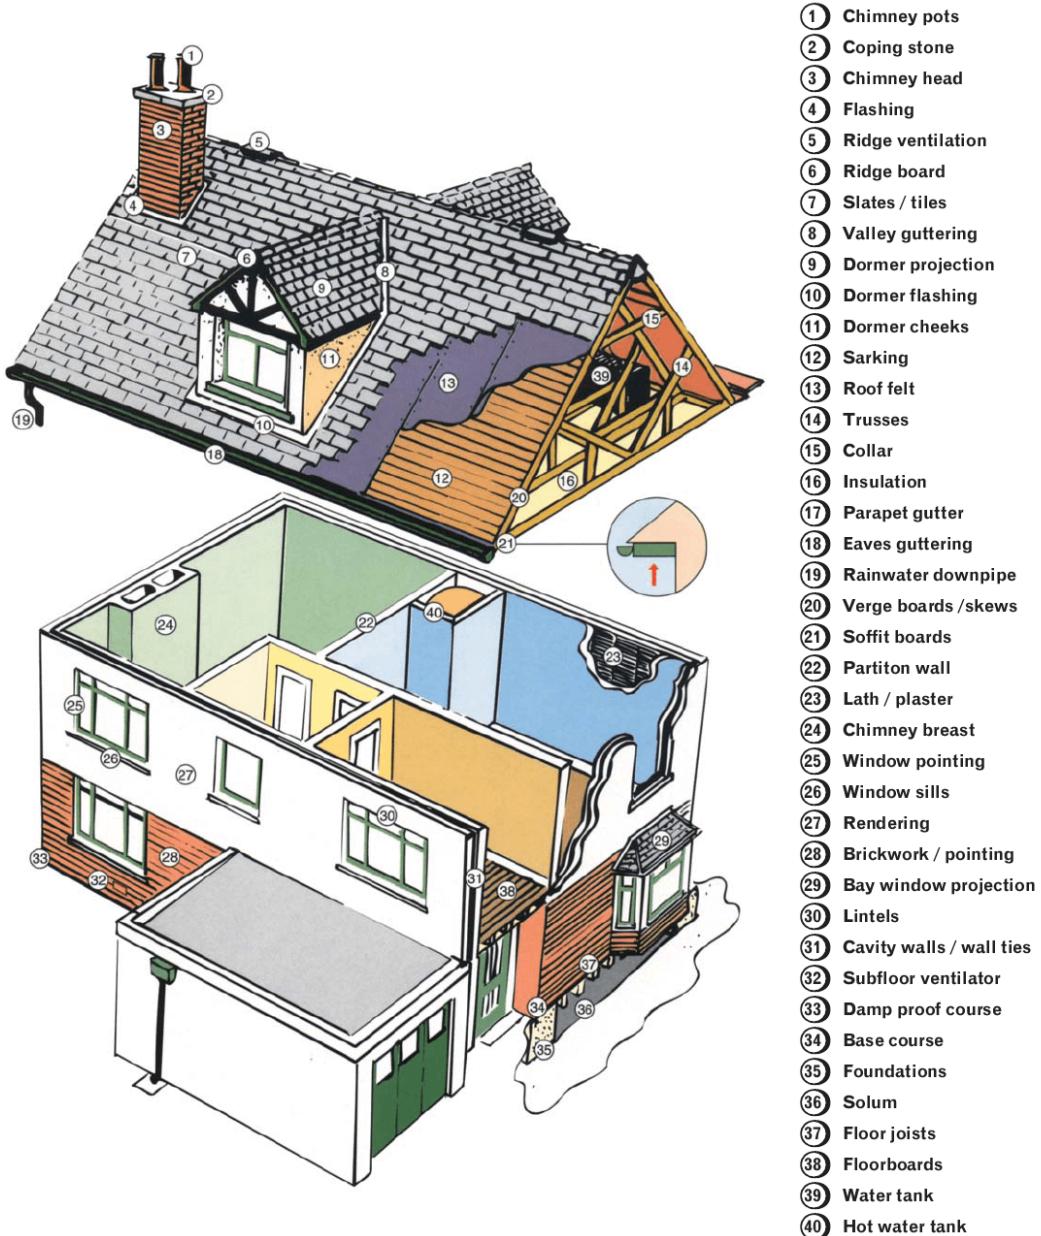
## Sectional Diagram showing elements of a typical house

Reference may be made in this report to some or all of the above component parts of the property. This diagram may assist you in locating and understanding these items.

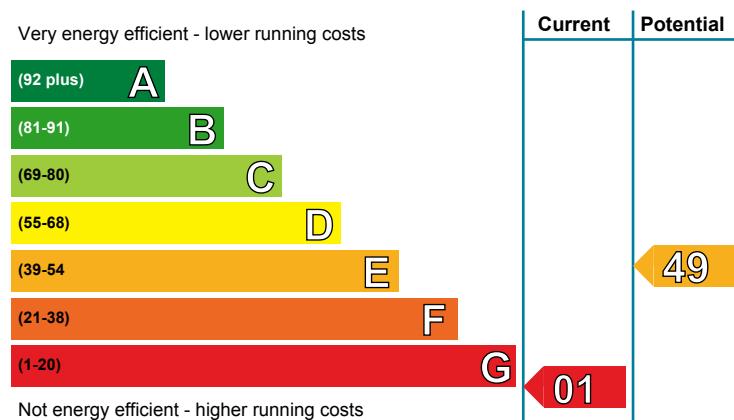
## Energy Efficiency Rating

This graph shows the current efficiency of your home, taking into account both energy efficiency and fuel costs. The higher this rating, the lower your fuel bills are likely to be.

Your current rating is **band G (1)**. The average rating for EPCs in Scotland is **band D (61)**.

The potential rating shows the effect of undertaking all of the improvement measures listed within your recommendations report.

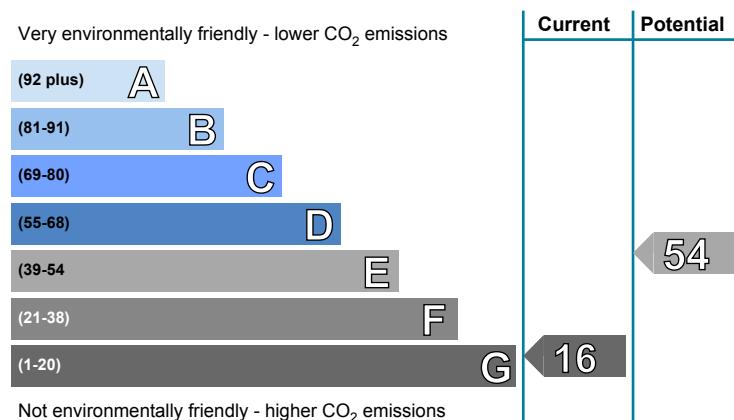
## Environmental Impact (CO<sub>2</sub>) Rating

This graph shows the effect of your home on the environment in terms of carbon dioxide (CO<sub>2</sub>) emissions. The higher the rating, the less impact it has on the environment.
