# Home Report

# Scottish Single Survey

| <b>Property address</b> | 4a Allan Street<br>Blairgowrie<br>PH10 6AD |

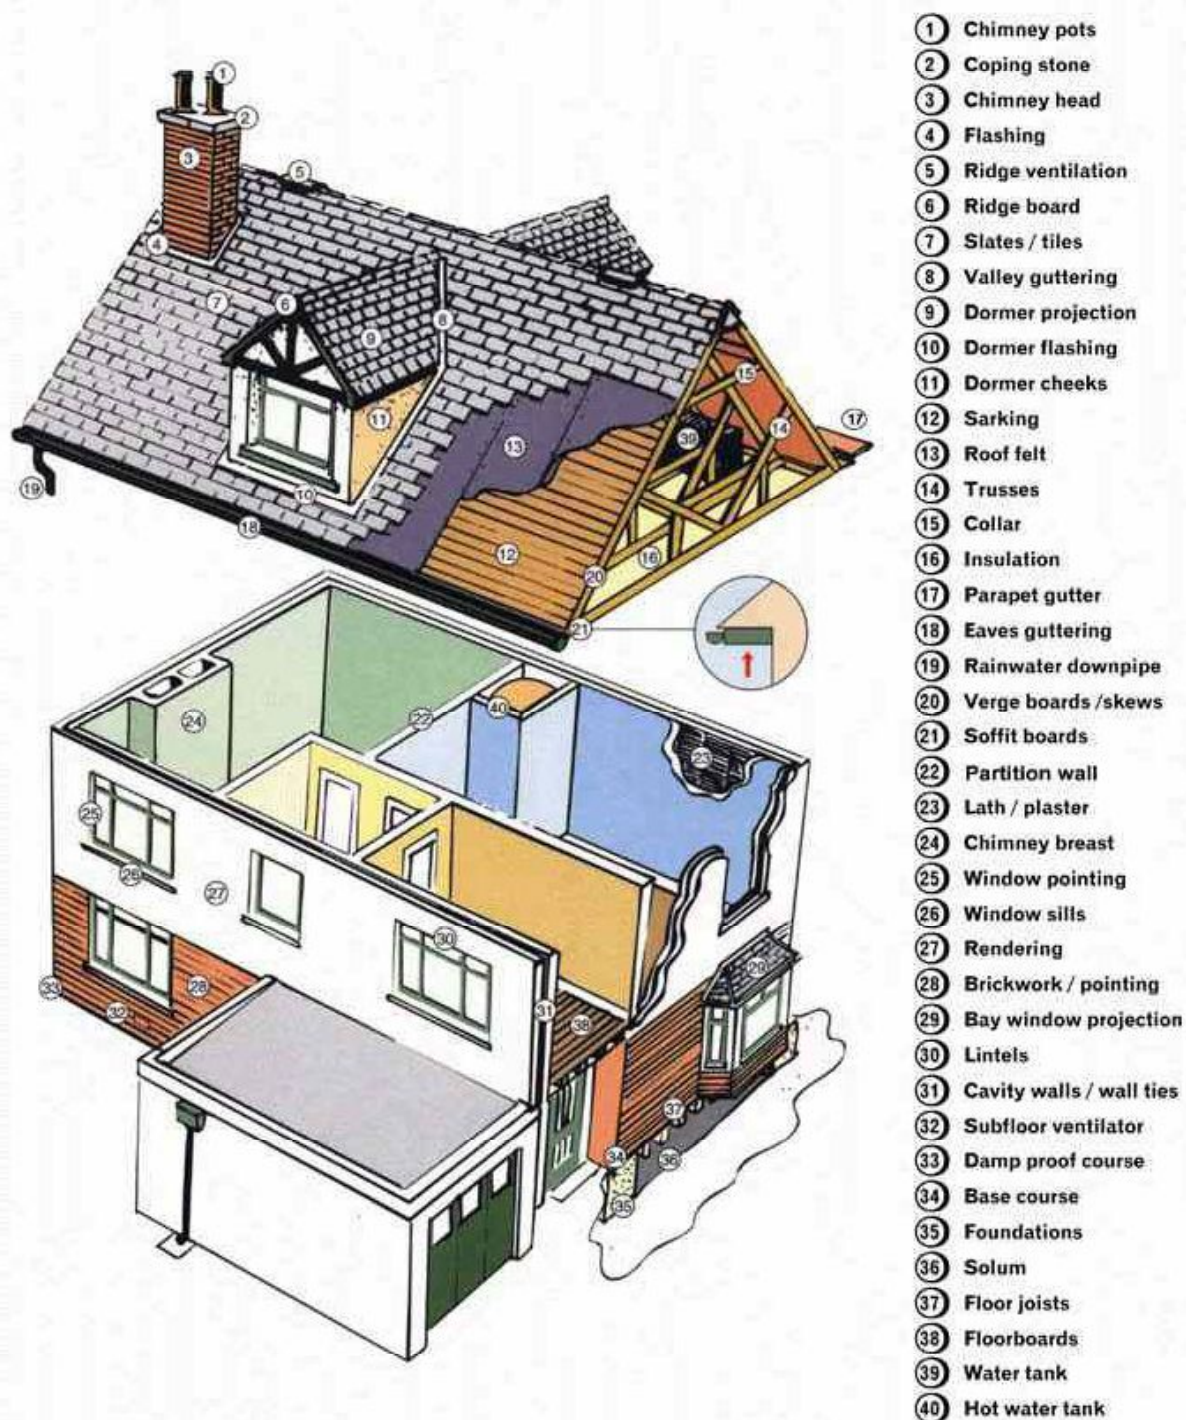
## Sectional Diagram showing elements of a typical house

Reference may be made in this report to some or all of the above component parts of the property. This diagram may assist you in locating and understanding these items.

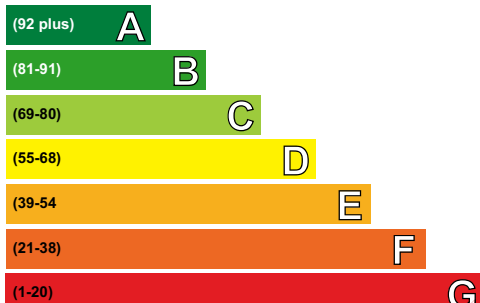
\* based upon the cost of energy for heating, hot water, lighting and ventilation, calculated using standard assumptions

Very energy efficient - lower running costs

Not energy efficient - higher running costs

The potential rating shows the effect of undertaking all of the improvement measures listed within your recommendations report.

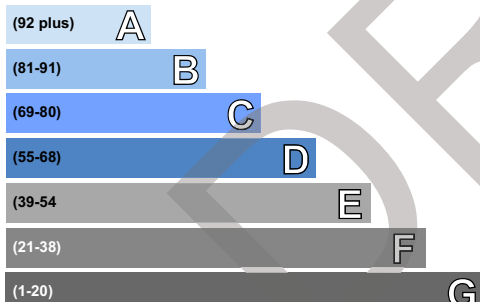
Very environmentally friendly - lower CO<sub>2</sub> emissions

Not environmentally friendly - higher CO<sub>2</sub> emissions
