Home Report

Single Survey

Property address	9 Carselea Road Invergowrie Dundee DD2 5AW
Customer	Mr & Mrs Duncan
Customer address	9 Carselea Road Invergowrie Dundee DD2 5AW
Prepared by	Shepherd Chartered Surveyors
Date of inspection	23/05/2025

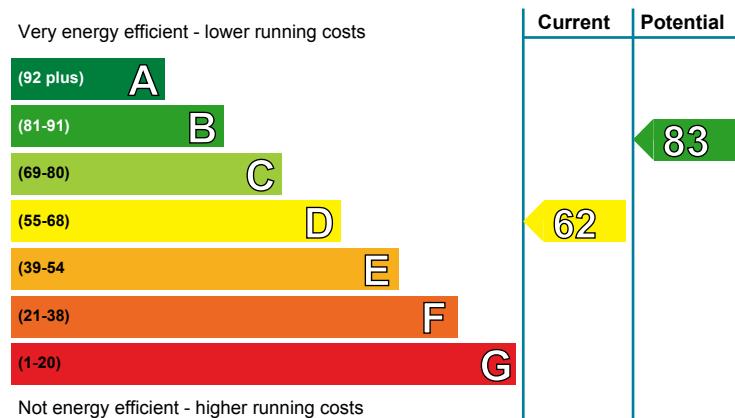
Energy Efficiency Rating

This graph shows the current efficiency of your home, taking into account both energy efficiency and fuel costs. The higher this rating, the lower your fuel bills are likely to be.

Your current rating is **band D (62)**. The average rating for EPCs in Scotland is **band D (61)**.

The potential rating shows the effect of undertaking all of the improvement measures listed within your recommendations report.

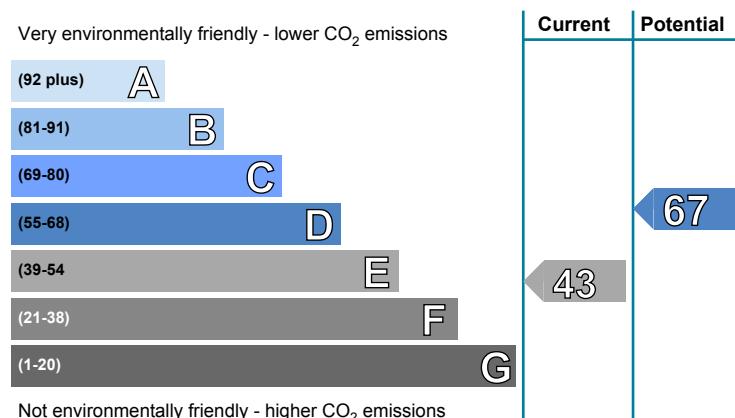
Environmental Impact (CO₂) Rating

This graph shows the effect of your home on the environment in terms of carbon dioxide (CO₂) emissions. The higher the rating, the less impact it has on the environment.
