Home Report

Scottish Single Survey

Single Survey

Property address	Hillcrest Kirk Wynd Blairgowrie PH10 6HN
Customer	Mr David Gill
Customer address	
Prepared by	Shepherd Chartered Surveyors
Date of inspection	04/06/2025

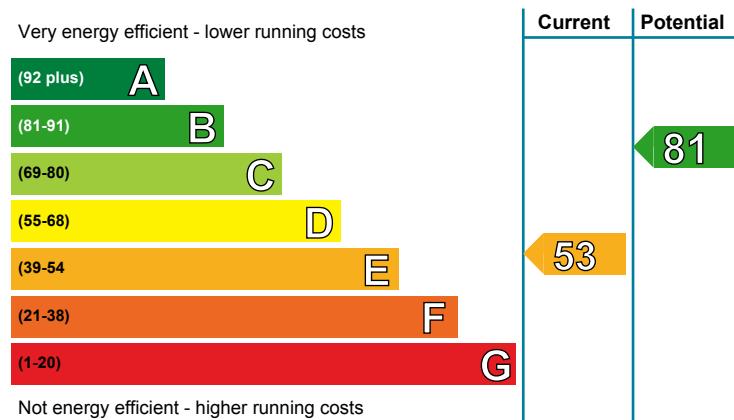
Energy Efficiency Rating

This graph shows the current efficiency of your home, taking into account both energy efficiency and fuel costs. The higher this rating, the lower your fuel bills are likely to be.

Your current rating is **band E (53)**. The average rating for EPCs in Scotland is **band D (61)**.

The potential rating shows the effect of undertaking all of the improvement measures listed within your recommendations report.

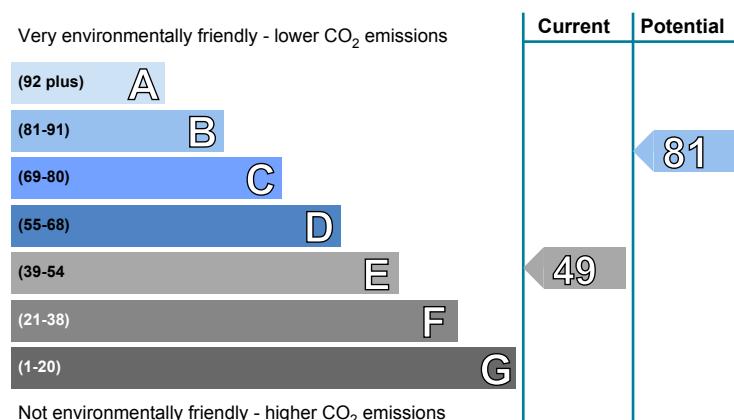
Environmental Impact (CO₂) Rating

This graph shows the effect of your home on the environment in terms of carbon dioxide (CO₂) emissions. The higher the rating, the less impact it has on the environment.
